Title: **DSP-30 Strain Relief Removal**
Bulletin #: DSP0005 Issue Date: May 30, 2003
Models Affected: DSP-30 Bulletin Revision: A
Production Range: 09/2001-5/2003 (serial# 0901xxxxx-0503xxxxx)

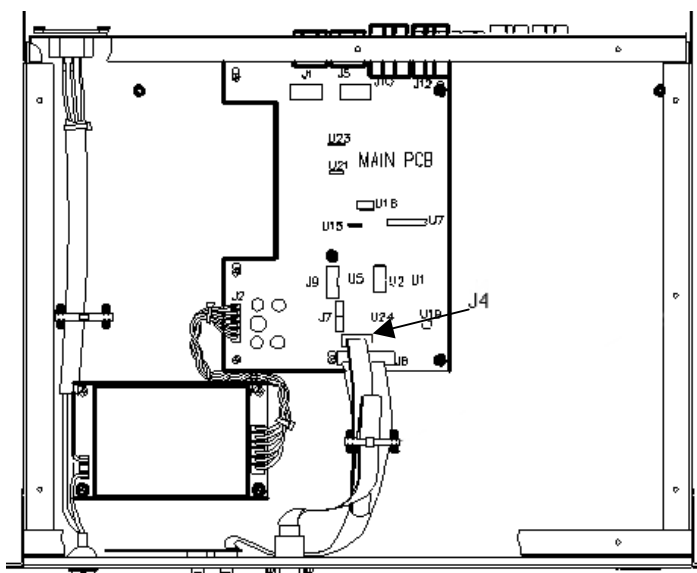
The RS232 ribbon cable that connects to the main DSP board does not latch properly.

Figure 1. The RS232 ribbon cable that connects to J4 on the main PCB.

1. Disconnect the DSP from AC and wait at least 10 minutes for internal voltages to bleed down.
2. Remove the top cover.
3. Locate the RS232 cable that connects to J4 and remove. Refer to *figure 1*.
4. Use small diagonal cutters to cut one end of the strain relief. Refer to *figure 2*.
5. Remove the remaining strain relief.
6. Reconnect the header into J4 and make sure it locks. Refer to *figure 3*.
7. Re-install the top cover and return the unit to service.

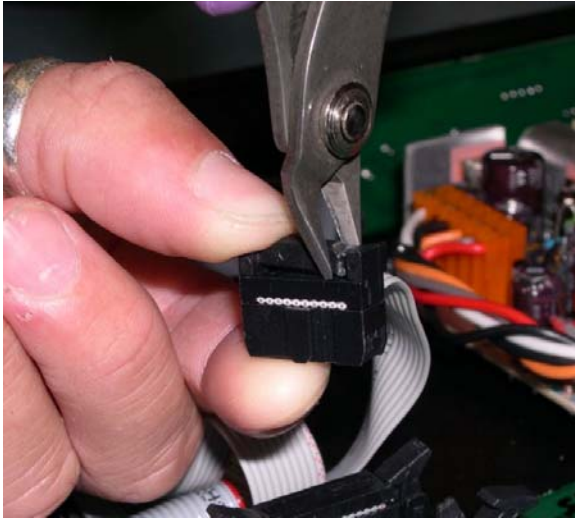
Figure 2. Removing the strain relief.

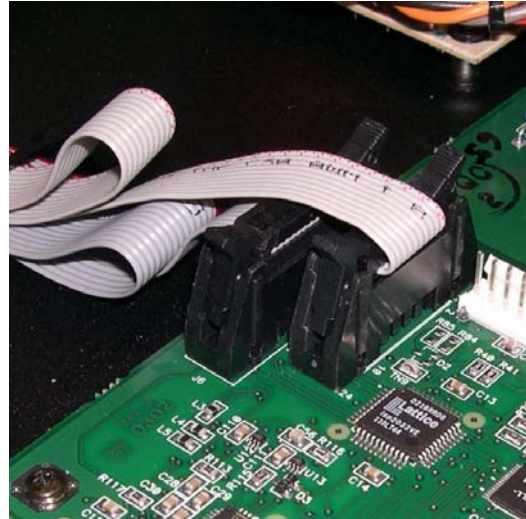
Figure 3. Reconnecting the header.
